**Flood Control Project Maintenance
Levee Inspections****LMA District Cover Sheet****Spring 2014 Levee Inspection Results****American River Flood Control District**

Spring 2014 Levee Inspection Results

American River Flood Control District

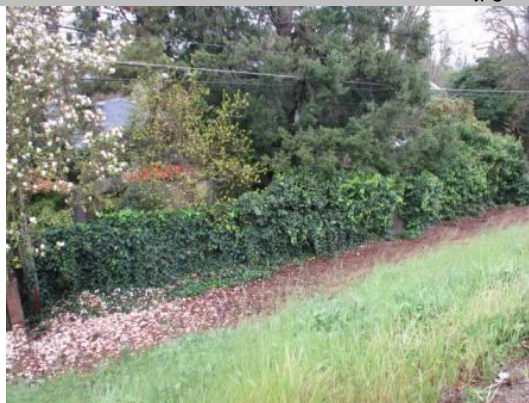
Photo 1 of 1 : mkhashch_s_20140428_00122.jpg

LM Start	5.79	Rating **	U	Issue No.	61
LM End	5.79	Issue Type +	En	Location *	LS
Category	Earthen Levee			GPS Latitude/Longitude	
				Start	End
Item	Vegetation			38.572918 °	38.572918 °
				-121.423760 °	-121.423760 °
DWR ID	DWR_NA0001_04_s _ 2012_61				
Action/Comments					
Landscaping					
Inspector Comments: Dense ivy and shrubs are within 10-ft of the levee toe.

03/16/2012 Landscaping obstructs access and visibility.

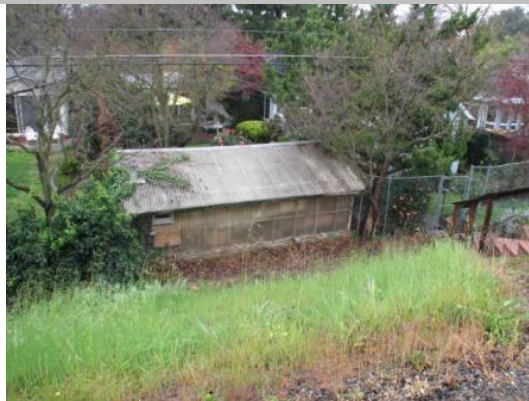
Photo 1 of 1 : mkhashch_s_20140428_00123.jpg

LM Start	5.83	Rating **	U	Issue No.	63
LM End	5.83	Issue Type +	En	Location *	LS
Category	Earthen Levee			GPS Latitude/Longitude	
				Start	End
Item	Encroachments			38.572325 °	38.572325 °
				-121.423913 °	-121.423913 °
DWR ID	DWR_NA0001_04_s _ 2012_63				
Action/Comments					
Building Inspector Comments: Wood and fiberglass structure within 10-ft of the levee toe.

03/16/2012 Wood and fiberglass structure is within 15' of levee toe.

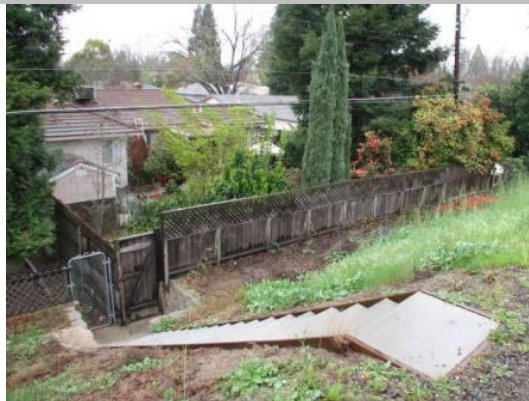
Photo 1 of 1 : mkhashch_s_20140428_00124.jpg

LM Start	5.85	Rating **	U	Issue No.	65
LM End	5.85	Issue Type +	En	Location *	LS
Category	Earthen Levee			GPS Latitude/Longitude	
				Start	End
Item	Encroachments			38.572067 °	38.572067 °
				-121.423970 °	-121.423970 °
DWR ID	DWR_NA0001_04_s _ 2012_65				
Action/Comments					
Fence Inspector Comments: Extended privacy fence and retaining wall within 10-ft of levee toe.

03/16/2012 Wood privacy fence completely obstructs access and visibility.

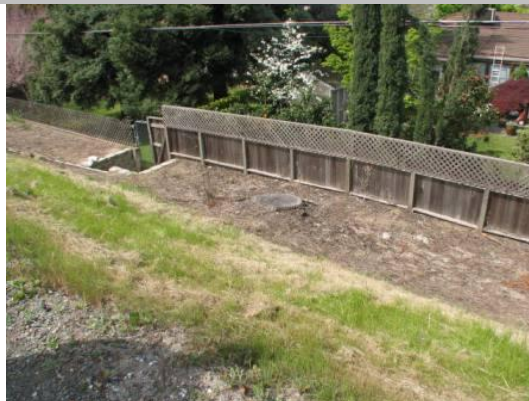
Photo 1 of 1 : mkhashch_s_20140428_00233.jpg

LM Start	5.85	Rating **	N	Issue No.	181
LM End	5.85	Issue Type +	Ma	Location *	LS
Category	Earthen Levee			GPS Latitude/Longitude	
				Start	End
Item	Trim / Thin Trees			38.572032 °	38.572032 °
				-121.423981 °	-121.423981 °
DWR ID	DWR_NA0001_04_s _ 2012_181				
Action/Comments					
Tree stumps. Inspector Comments: 04/14/2011 Large stump at toe of levee.

04/14/2011 Large stump at toe of levee.

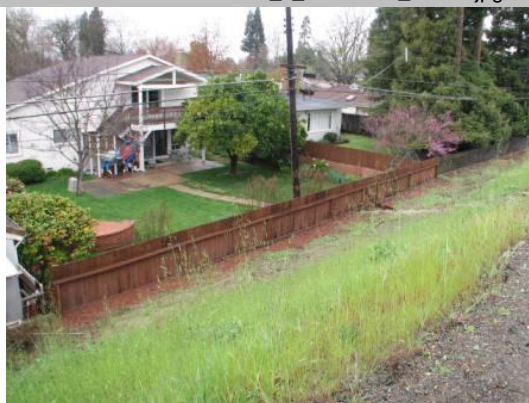
Photo 1 of 1 : mkhashch_s_20140428_00254.jpg

LM Start	5.87	Rating **	U	Issue No.	210
LM End	5.87	Issue Type +	En	Location *	LS
Category	Earthen Levee			GPS Latitude/Longitude	
				Start	End
Item	Encroachments			38.571733 °	38.571733 °
				-121.424055 °	-121.424055 °
DWR ID	DWR_NA0001_04_s _ 2012_210				
Action/Comments					
Fence					
Inspector Comments: Privacy fence and retaining wall are within 10-ft of levee toe.

03/16/2012 Wood privacy fence completely obstructs access and visibility.

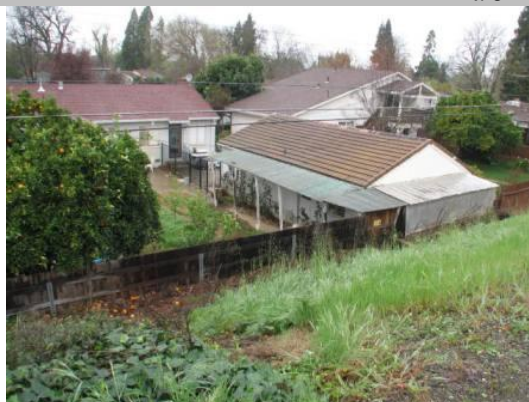
Photo 1 of 1 : mkhashch_s_20140428_00125.jpg

LM Start	5.88	Rating **	U	Issue No.	66
LM End	5.88	Issue Type +	En	Location *	LS
Category	Earthen Levee			GPS Latitude/Longitude	
				Start	End
Item	Encroachments			38.571586 °	38.571586 °
				-121.424097 °	-121.424097 °
DWR ID	DWR_NA0001_04_s _ 2012_66				
Action/Comments					
Building

03/16/2012 Structure is within 15' of levee toe.

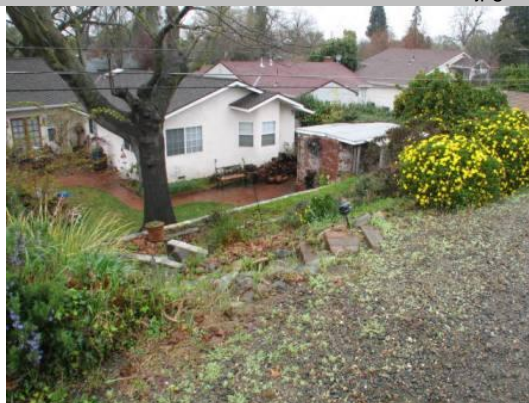
Photo 1 of 1 : mkhashch_s_20140428_00127.jpg

LM Start	5.89	Rating **	U	Issue No.	68
LM End	5.89	Issue Type +	En	Location *	LS
Category	Earthen Levee			GPS Latitude/Longitude	
				Start	End
Item	Vegetation			38.571525 °	38.571525 °
				-121.424152 °	-121.424152 °
DWR ID	DWR_NA0001_04_f_2013_68				
Action/Comments					
Landscaping Inspector Comments: Levee slope has been landscaped. This obstructs visibility.

03/16/2012 Levee slope is heavily landscaped, retaining wall has been constructed at the levee toe.

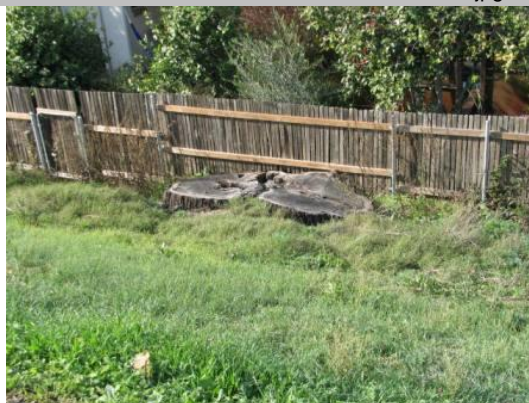
Photo 1 of 1 : mkhashch_s_20140428_00267.jpg

LM Start	5.93	Rating **	N	Issue No.	740
LM End	5.93	Issue Type +	Ma	Location *	LS
Category	Earthen Levee			GPS Latitude/Longitude	
				Start	End
Item	Trim / Thin Trees			38.570940 °	38.570940 °
				-121.424173 °	-121.424173 °
DWR ID	DWR_NA0001_04_s_2012_740				
Action/Comments					
Tree stumps.					
Inspector Comments: Large stump

11/15/2011 Large stump at levee toe.

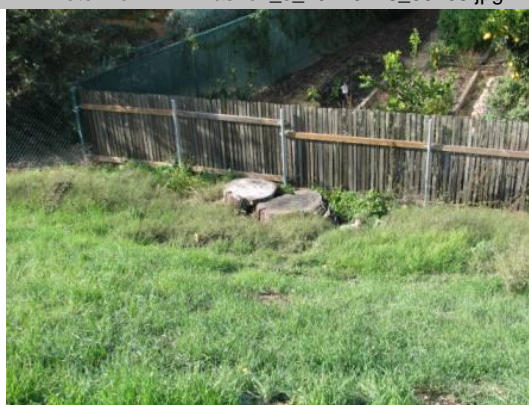
Photo 1 of 1 : mkhashch_s_20140428_00268.jpg

LM Start	5.94	Rating **	N	Issue No.	741
LM End	5.94	Issue Type +	Ma	Location *	LS
Category	Earthen Levee			GPS Latitude/Longitude	
				Start	End
Item	Trim / Thin Trees			38.570800 °	38.570800 °
				-121.424184 °	-121.424184 °
DWR ID	DWR_NA0001_04_s_2012_741				
Action/Comments					
Tree stumps.					
Inspector Comments: Stump.

11/15/2011 Stump at levee toe.

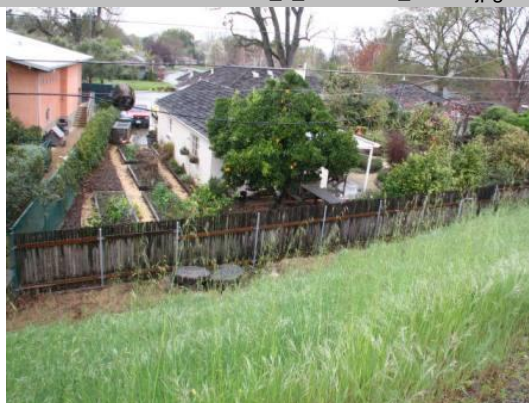
Photo 1 of 1 : mkhashch_s_20140428_00144.jpg

LM Start	5.94	Rating **	U	Issue No.	88
LM End	5.94	Issue Type +	En	Location *	LS
Category	Earthen Levee			GPS Latitude/Longitude	
				Start	End
Item	Encroachments			38.570752 °	38.570752 °
				-121.424219 °	-121.424219 °
DWR ID	DWR_NA0001_04_f_2012_88				
Action/Comments					
Fence					
Inspector Comments: Wooden privacy fence.

03/16/2012 Wood privacy fence completely obstructs access and visibility.

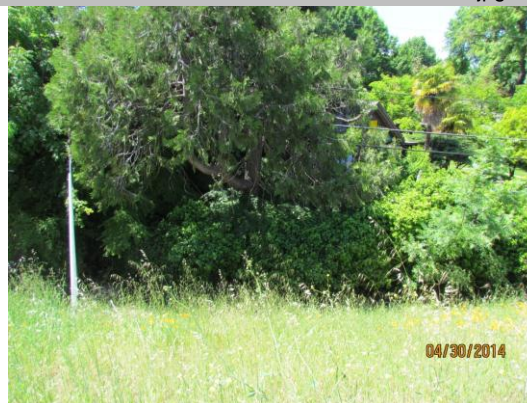
Photo 1 of 1 : mkhashch_s_20140509_00974.jpg

LM Start	5.97	Rating **	M	Issue No.	71
LM End	5.97	Issue Type +	En	Location *	LS
Category	Earthen Levee			GPS Latitude/Longitude	
				Start	End
Item	Vegetation			38.570450 °	38.570450 °
				-121.424237 °	-121.424237 °
DWR ID	DWR_NA0001_04_s _ 2012_71				
Action/Comments					
Landscaping Inspector Comments: Landscaping and garden within 10-ft of the levee toe.

View of the landscaping at the landside levee toe.

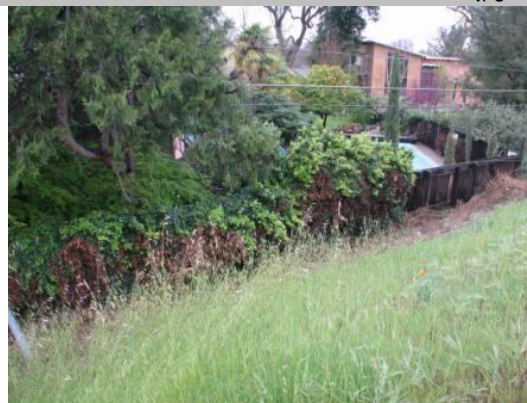
Photo 1 of 1 : mkhashch_s_20140428_00128.jpg

LM Start	5.97	Rating **	U	Issue No.	72
LM End	5.97	Issue Type +	En	Location *	LS
Category	Earthen Levee			GPS Latitude/Longitude	
				Start	End
Item	Encroachments			38.570391 °	38.570391 °
				-121.424227 °	-121.424227 °
DWR ID	DWR_NA0001_04_s _ 2012_72				
Action/Comments					
Fence Inspector Comments: Wood fence and landscaping within 10-ft of the levee toe obstructs visibility.

03/16/2012 Wood privacy fence completely obstructs access and visibility.

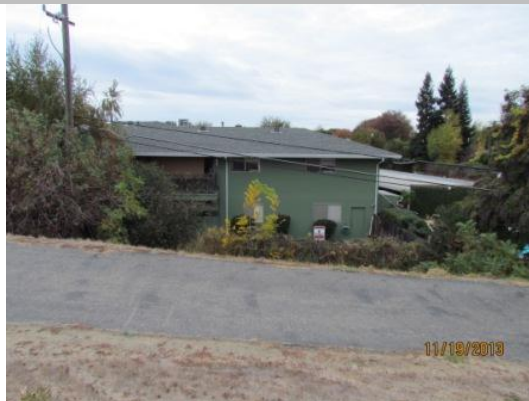
Photo 1 of 1 : mkhashch_s_20140428_00255.jpg

LM Start	6.00	Rating **	M	Issue No.	211
LM End	6.00	Issue Type +	En	Location *	LS
Category	Earthen Levee			GPS Latitude/Longitude	
				Start	End
Item	Encroachments			38.569893 °	38.569893 °
				-121.424310 °	-121.424310 °
DWR ID	DWR_NA0001_04_s_2012_211				
Action/Comments					
Fence					
Inspector Comments: Apartment complex privacy fence and shrubs within 10-ft of the slope obstruct visibility.

View of the fence at the landside levee toe.

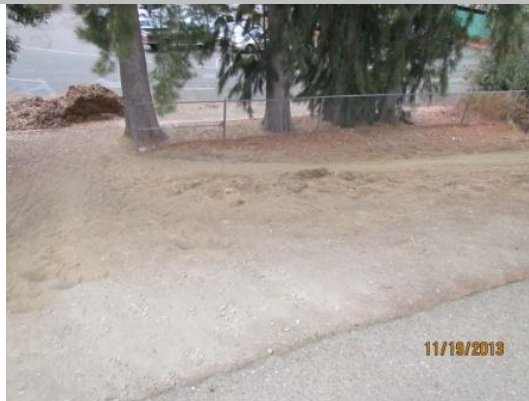
Photo 1 of 1 : mkhashch_s_20140428_00249.jpg

View of the foot traffic on the landside levee slope.

LM Start	6.28	Rating **	A/W	Issue No.	203
LM End	6.28	Issue Type +	Ma	Location *	LS
Category	Earthen Levee			GPS Latitude/Longitude	
				Start	End
Item	Slope Stability			38.566079 °	38.566079 °
				-121.423505 °	-121.423505 °
DWR ID	DWR_NA0001_04_f_2013_203				
Action/Comments					
Repair the levee slope damaged by foot traffic and prevent access where possible.

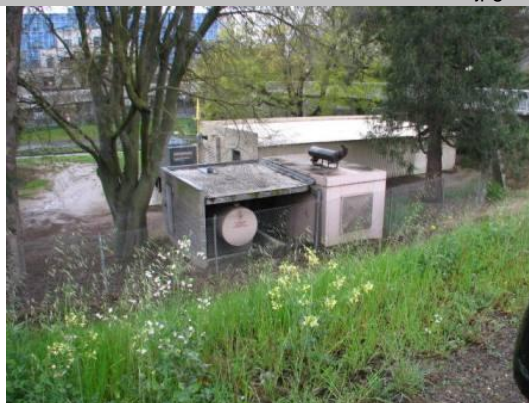
Photo 1 of 1 : mkhashch_s_20140428_00129.jpg

LM Start	6.61	Rating **	U	Issue No.	73
LM End	6.61	Issue Type +	En	Location *	LS
Category	Earthen Levee			GPS Latitude/Longitude	
				Start	End
Item	Encroachments			38.561643 °	38.561643 °
				-121.421262 °	-121.421262 °
DWR ID	DWR_NA0001_04_s_2012_73				
Action/Comments					
Building					
Inspector Comments: Generator and sheds within 10-ft of levee slope.

03/16/2012 Structure for generator is within 5' of levee toe.

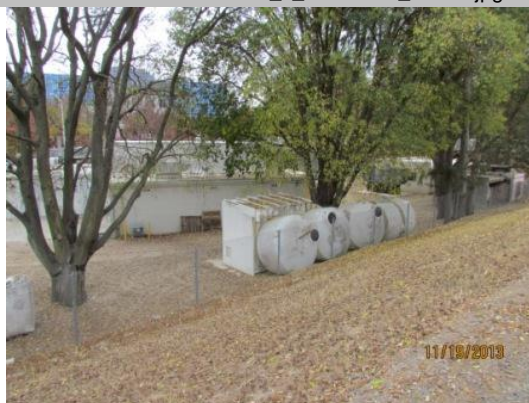
Photo 1 of 1 : mkhashch_s_20140428_00236.jpg

LM Start	6.63	Rating **	M	Issue No.	185
LM End	6.63	Issue Type +	En	Location *	LS
Category	Earthen Levee			GPS Latitude/Longitude	
				Start	End
Item	Encroachments			38.561448 °	38.561448 °
				-121.421071 °	-121.421071 °
DWR ID	DWR_NA0001_04_f_2013_185				
Action/Comments					
Tank					
Inspector Comments: 5 water tanks and storage shed within 10 feet of landside levee toe.

View of the water tanks stored at the landside levee toe.

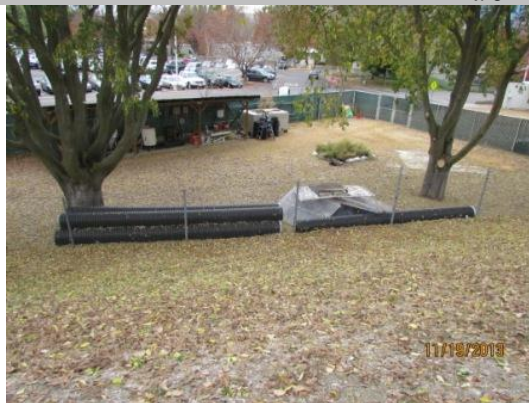
Photo 1 of 1 : mkhashch_s_20140428_00114.jpg

LM Start	6.66	Rating **	M	Issue No.	51
LM End	6.66	Issue Type +	En	Location *	LS
Category	Earthen Levee			GPS Latitude/Longitude	
				Start	End
Item	Encroachments			38.561117 °	38.561117 °
				-121.420749 °	-121.420749 °
DWR ID	DWR_NA0001_04_f_2013_51				
Action/Comments					
Material					
Inspector Comments: Pipe and other material stored within 10 feet of landside levee toe.

View of the material stored at the landside levee toe.

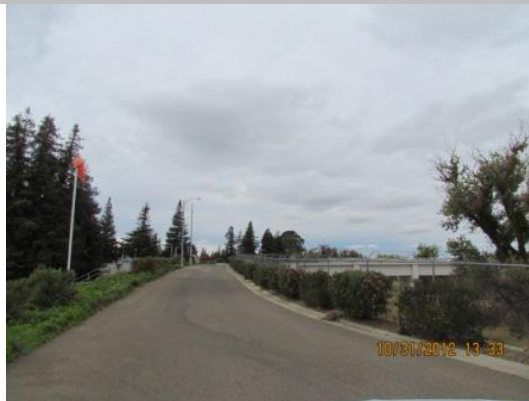
Photo 1 of 1 : mkhashch_s_20140428_00194.jpg

LM Start	6.85	Rating **	M	Issue No.	140
LM End	6.98	Issue Type +	En	Location *	WS
Category	Earthen Levee			GPS Latitude/Longitude	
				Start	End
Item	Vegetation			38.559152 °	38.558115 °
				-121.418108 °	-121.416328 °
DWR ID	DWR_NA0001_04_f_2012_140				
Action/Comments					
Landscaping Inspector Comments: Bushes at waterside hinge obstruct visibility of waterside slope from levee crown.

View of landscaping at waterside hinge obstructing visibility.

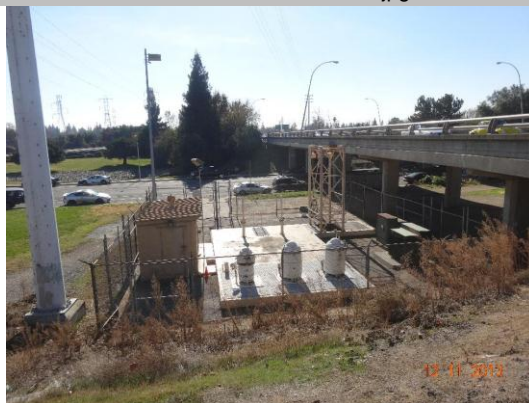
Photo 1 of 1 : UCIP_6261.jpg

LM Start	7.38	Rating **	M	Issue No.	241
LM End	7.38	Issue Type +	En	Location *	WS
Category	Supplemental			GPS Latitude/Longitude	
				Start	End
Item	DWR UCIP Field Study			38.558197 °	38.558197 °
				-121.409106 °	-121.409106 °
DWR ID	DWR_NA0001_04_s_2014_241				
Action/Comments					
Inspector Comments: FS_ID:30023					
EP_NO: 3596					
Repair Type:					
Crossing Status:					
UCIP Comments: Need to contact owners to determine how crossing was abandoned.					
FIELD_STRUCT_DESC: [Power Inn Road Plant] 4 of 4: Abandoned 48-inch CM drainpipe through the levee, 20.0 feet below the crown. Two CM cutoff walls around pipe under each shoulder. Slide gate with control pedestal in CM pipe riser on waterward slope. Slide gate with control pedestal in collection sump on landward side. Pumping plant at landward toe. Reinforced concrete discharge box at the toe of the water ward slope. Flap gate on waterward end. (Permit No. 3596-1962) 60-inch discharge pipe from box across the berm to the riverbank installed under Permit No. 5894 (1970). Pipe abandoned and CM pipe riser cut 2.0 feet below ground surface under Permit No. 3596A (1998).

Pump station located on landward side.

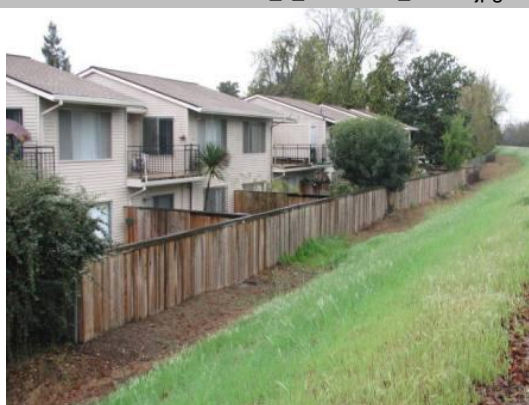
Photo 1 of 1 : mkhashch_s_20140428_00130.jpg

LM Start	7.70	Rating **	U	Issue No.	74
LM End	7.73	Issue Type +	En	Location *	LS
Category	Earthen Levee			GPS Latitude/Longitude	
				Start	End
Item	Encroachments			38.559177 °	38.559218 °
				-121.403541 °	-121.402967 °
DWR ID	DWR_NA0001_04_s_2012_74				
Action/Comments					
Fence					
Inspector Comments: Wooden privacy fence for seven apartment units is within 10-ft of levee toe and obstructs access and visibility.

03/16/2012 Wood privacy fence completely obstructs access and visibility.

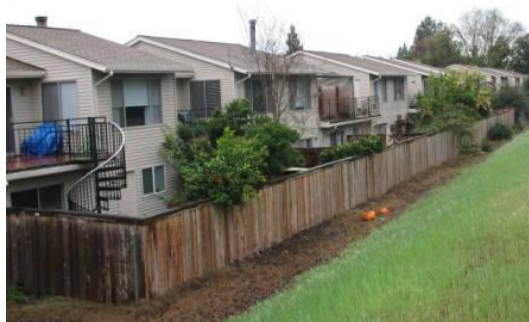
Photo 1 of 1 : mkhashch_s_20140428_00131.jpg

LM Start	7.75	Rating **	U	Issue No.	75
LM End	7.77	Issue Type +	En	Location *	LS
Category	Earthen Levee			GPS Latitude/Longitude	
				Start	End
Item	Encroachments			38.559230 °	38.559261 °
				-121.402708 °	-121.402219 °
DWR ID	DWR_NA0001_04_s _ 2012_75				
Action/Comments					
Fence					
Inspector Comments: Wooden privacy fence for seven apartment units is within 10-ft of levee toe and obstructs access and visibility.

03/16/2012 Wood privacy fence completely obstructs access and visibility.

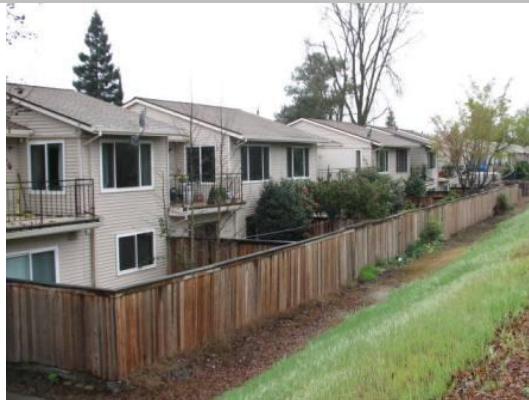
Photo 1 of 1 : mkhashch_s_20140428_00132.jpg

LM Start	7.80	Rating **	U	Issue No.	76
LM End	7.82	Issue Type +	En	Location *	LS
Category	Earthen Levee			GPS Latitude/Longitude	
				Start	End
Item	Encroachments			38.559308 °	38.559309 °
				-121.401717 °	-121.401388 °
DWR ID	DWR_NA0001_04_s _ 2012_76				
Action/Comments					
Fence					
Inspector Comments: Wooden privacy fence for seven apartment units is within 10-ft of levee toe and obstructs access and visibility.

03/16/2012 Wood privacy fence completely obstructs access and visibility.

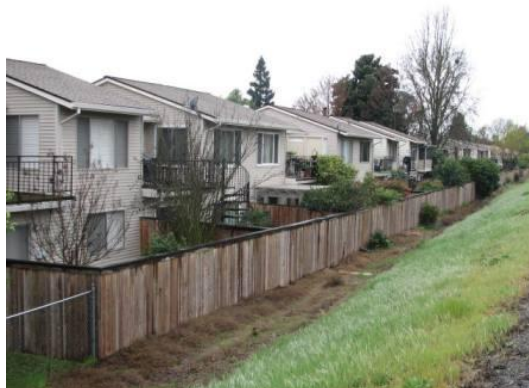
Photo 1 of 1 : mkhashch_s_20140428_00133.jpg

LM Start	7.83	Rating **	U	Issue No.	77
LM End	7.86	Issue Type +	En	Location *	LS
Category	Earthen Levee			GPS Latitude/Longitude	
				Start	End
Item	Encroachments			38.559330 °	38.559366 °
				-121.401162 °	-121.400683 °
DWR ID	DWR_NA0001_04_s _ 2012_77				
Action/Comments					
Fence					
Inspector Comments: Wooden privacy fence for seven apartment units is within 10-ft of levee toe and obstructs access and visibility.

03/16/2012 Wood privacy fence completely obstructs access and visibility.

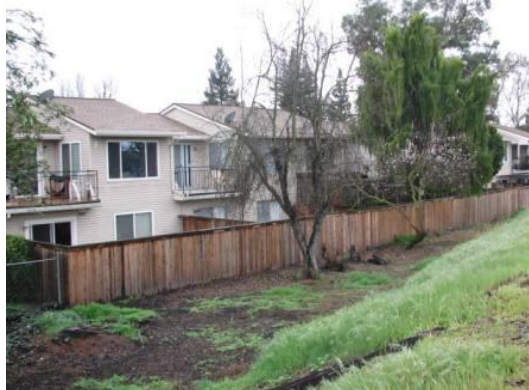
Photo 1 of 1 : mkhashch_s_20140428_00134.jpg

LM Start	7.88	Rating **	U	Issue No.	78
LM End	7.90	Issue Type +	En	Location *	LS
Category	Earthen Levee			GPS Latitude/Longitude	
				Start	End
Item	Encroachments			38.559379 °	38.559435 °
				-121.400354 °	-121.399944 °
DWR ID	DWR_NA0001_04_s _ 2012_78				
Action/Comments					
Fence					
Inspector Comments: Wooden privacy fence for seven apartment units is within 10-ft of levee toe and obstructs access and visibility.

03/16/2012 Wood privacy fence completely obstructs access and visibility.

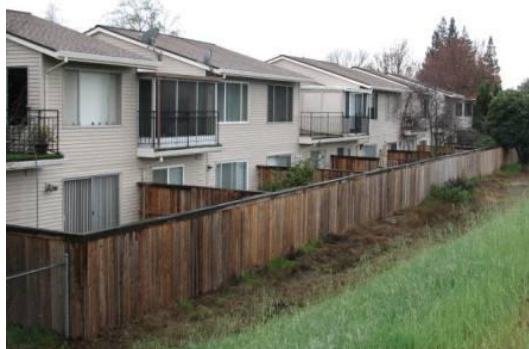
Photo 1 of 1 : mkhashch_s_20140428_00135.jpg

LM Start	7.91	Rating **	U	Issue No.	79
LM End	7.94	Issue Type +	En	Location *	LS
Category	Earthen Levee			GPS Latitude/Longitude	
				Start	End
Item	Encroachments			38.559514 °	38.559643 °
				-121.399700 °	-121.399248 °
DWR ID	DWR_NA0001_04_s _ 2012_79				
Action/Comments					
Fence					
Inspector Comments: Wooden privacy fence for seven apartment units is within 10-ft of levee toe and obstructs access and visibility.

03/16/2012 Wood privacy fence completely obstructs access and visibility.

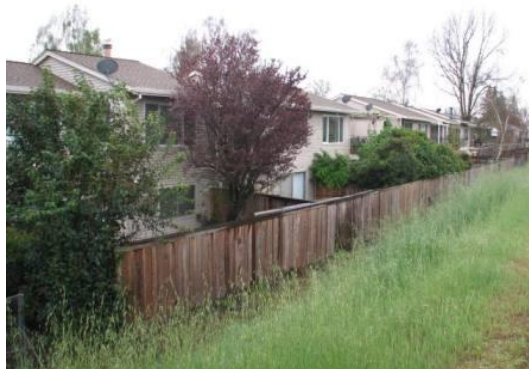
Photo 1 of 1 : mkhashch_s_20140428_00136.jpg

LM Start	7.96	Rating **	U	Issue No.	80
LM End	7.98	Issue Type +	En	Location *	LS
Category	Earthen Levee			GPS Latitude/Longitude	
				Start	End
Item	Encroachments			38.559753 °	38.559911 °
				-121.398982 °	-121.398506 °
DWR ID	DWR_NA0001_04_s _ 2012_80				
Action/Comments					
Fence					
Inspector Comments: Wooden privacy fence for seven apartment units is within 10-ft of levee toe and obstructs access and visibility.

03/16/2012 Wood privacy fence completely obstructs access and visibility.

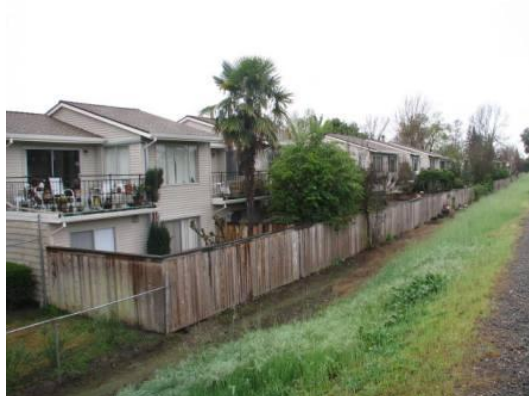
Photo 1 of 1 : mkhashch_s_20140428_00256.jpg

LM Start	8.00	Rating **	U	Issue No.	224
LM End	8.03	Issue Type +	En	Location *	LS
Category	Earthen Levee			GPS Latitude/Longitude	
				Start	End
Item	Encroachments			38.559994 °	38.560185 °
				-121.398318 °	-121.397845 °
DWR ID	DWR_NA0001_04_s _ 2012_224				
Action/Comments					
Fence					
Inspector Comments: Wooden privacy fence for seven apartment units is within 10-ft of levee toe and obstructs access and visibility.

03/16/2012 Wood privacy fence completely obstructs access and visibility.

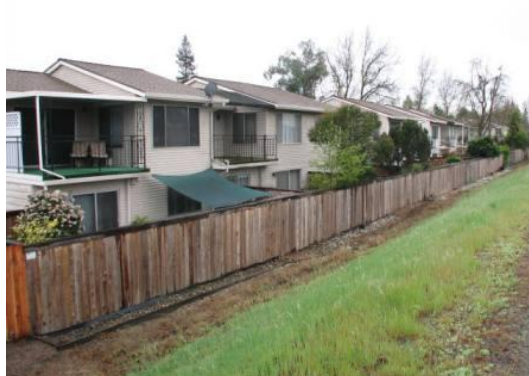
Photo 1 of 1 : mkhashch_s_20140428_00137.jpg

LM Start	8.04	Rating **	U	Issue No.	81
LM End	8.07	Issue Type +	En	Location *	LS
Category	Earthen Levee			GPS Latitude/Longitude	
				Start	End
Item	Encroachments			38.560281 °	38.560435 °
				-121.397604 °	-121.397239 °
DWR ID	DWR_NA0001_04_s _ 2012_81				
Action/Comments					
Fence					
Inspector Comments: Wooden privacy fence for seven apartment units is within 10-ft of levee toe and obstructs access and visibility.

03/16/2012 Wood privacy fence completely obstructs access and visibility.

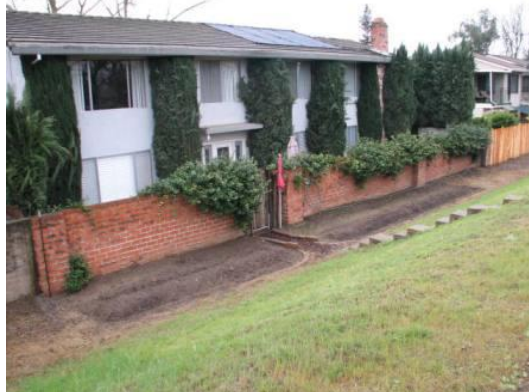
Photo 1 of 1 : mkhashch_s_20140428_00138.jpg

LM Start	8.09	Rating **	U	Issue No.	82
LM End	8.09	Issue Type +	En	Location *	LS
Category	Earthen Levee			GPS Latitude/Longitude	
				Start	End
Item	Encroachments			38.560537 °	38.560537 °
				-121.396912 °	-121.396912 °
DWR ID	DWR_NA0001_04_s _ 2012_82				
Action/Comments					
Fence					
Inspector Comments: Brick fence is within 10-ft of levee toe, obstructing access and visibility.

03/16/2012 Brick wall completely obstructs access and visibility.

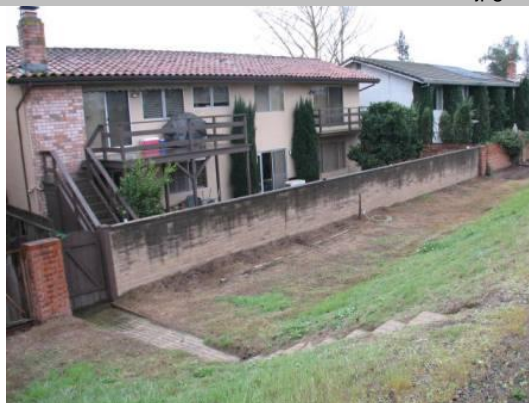
Photo 1 of 1 : mkhashch_s_20140428_00139.jpg

LM Start	8.10	Rating **	U	Issue No.	83
LM End	8.10	Issue Type +	En	Location *	LS
Category	Earthen Levee			GPS Latitude/Longitude	
				Start	End
Item	Encroachments			38.560647 °	38.560647 °
				-121.396660 °	-121.396660 °
DWR ID	DWR_NA0001_04_s _ 2012_83				
Action/Comments					
Fence Inspector Comments: Brick fence is within 10-ft of levee toe and obstructs access and visibility.

03/16/2012 Brick wall completely obstructs access and visibility.

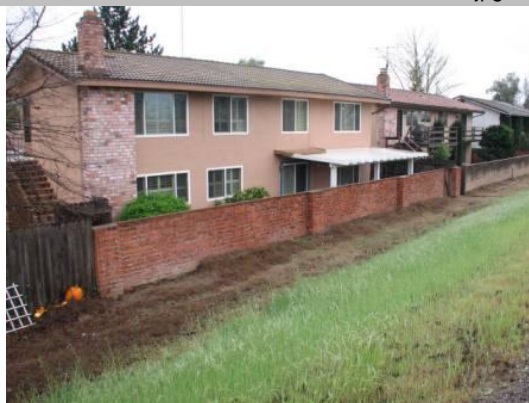
Photo 1 of 1 : mkhashch_s_20140428_00140.jpg

LM Start	8.11	Rating **	U	Issue No.	84
LM End	8.11	Issue Type +	En	Location *	LS
Category	Earthen Levee			GPS Latitude/Longitude	
				Start	End
Item	Encroachments			38.560728 °	38.560728 °
				-121.396471 °	-121.396471 °
DWR ID	DWR_NA0001_04_s _ 2012_84				
Action/Comments					
Fence Inspector Comments: Brick fence is within 10-ft of levee toe and obstructs access and visibility.

03/16/2012 Brick wall completely obstructs access and visibility.

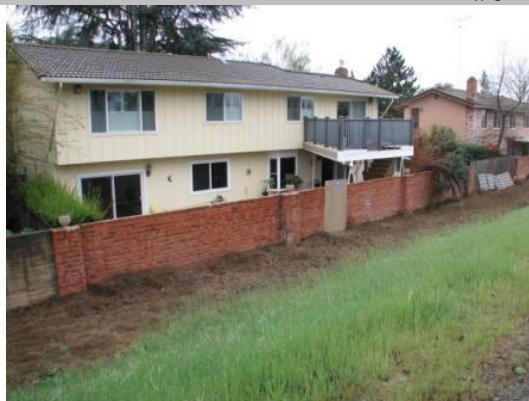
Photo 1 of 1 : mkhashch_s_20140428_00141.jpg

LM Start	8.13	Rating **	U	Issue No.	85
LM End	8.13	Issue Type +	En	Location *	LS
Category	Earthen Levee			GPS Latitude/Longitude	
				Start	End
Item	Encroachments			38.560845 °	38.560845 °
				-121.396189 °	-121.396189 °
DWR ID	DWR_NA0001_04_s _ 2012_85				
Action/Comments					
Fence					
Inspector Comments: Brick fence is within 10-ft of levee toe and obstructs access and visibility.

03/16/2012 Brick wall completely obstructs access and visibility.

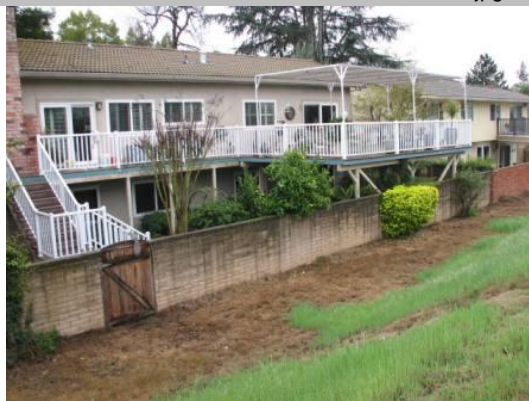
Photo 1 of 1 : mkhashch_s_20140428_00142.jpg

LM Start	8.14	Rating **	U	Issue No.	86
LM End	8.14	Issue Type +	En	Location *	LS
Category	Earthen Levee			GPS Latitude/Longitude	
				Start	End
Item	Encroachments			38.560907 °	38.560907 °
				-121.396043 °	-121.396043 °
DWR ID	DWR_NA0001_04_s _ 2012_86				
Action/Comments					
Fence Inspector Comments: Brick fence is within 10-ft of levee toe and obstructs access and visibility.

03/16/2012 Brick wall completely obstructs access and visibility.

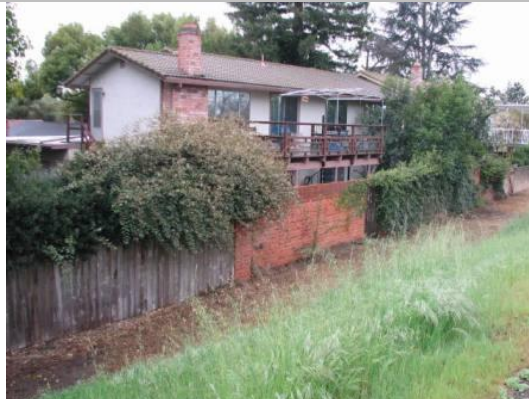
Photo 1 of 1 : mkhashch_s_20140428_00143.jpg

LM Start	8.15	Rating **	U	Issue No.	87
LM End	8.15	Issue Type +	En	Location *	LS
Category	Earthen Levee			GPS Latitude/Longitude	
				Start	End
Item	Encroachments			38.561008 °	38.561008 °
				-121.395817 °	-121.395817 °
DWR ID	DWR_NA0001_04_s _ 2012_87				
Action/Comments					
Fence					
Inspector Comments: Brick fence is within 10-ft of levee toe and obstructs access and visibility.

03/16/2012 Brick wall completely obstructs access and visibility.

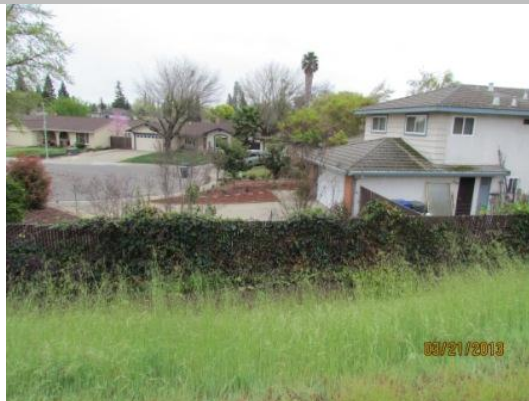
Photo 1 of 1 : mkhashch_s_20140428_00257.jpg

LM Start	8.19	Rating **	M	Issue No.	225
LM End	8.19	Issue Type +	En	Location *	LS
Category	Earthen Levee			GPS Latitude/Longitude	
				Start	End
Item	Vegetation			38.561248 °	38.561248 °
				-121.395169 °	-121.395169 °
DWR ID	DWR_NA0001_04_s _ 2012_225				
Action/Comments					
Landscaping Inspector Comments: Landscaping along chain link fence within 10-ft of levee toe obstructs access and visibility.

View of the landscaping at the levee toe.

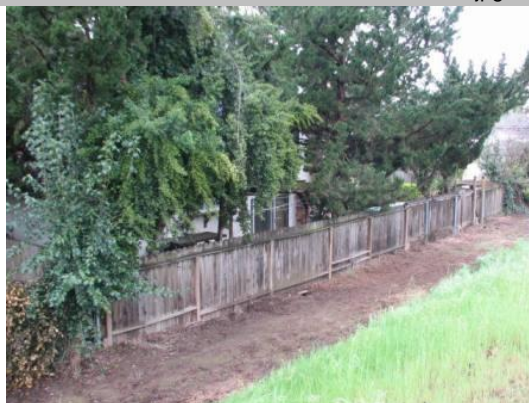
Photo 1 of 1 : mkhashch_s_20140428_00145.jpg

LM Start	8.22	Rating **	U	Issue No.	89
LM End	8.22	Issue Type +	En	Location *	LS
Category	Earthen Levee			GPS Latitude/Longitude	
				Start	End
Item	Encroachments			38.561467 °	38.561467 °
				-121.394728 °	-121.394728 °
DWR ID	DWR_NA0001_04_s _ 2012_89				
Action/Comments					
Fence					
Inspector Comments: Fence and landscaping arbor within 10-ft of levee toe obstructs access and visibility.

03/16/2012 Wood privacy fence completely obstructs access and visibility.

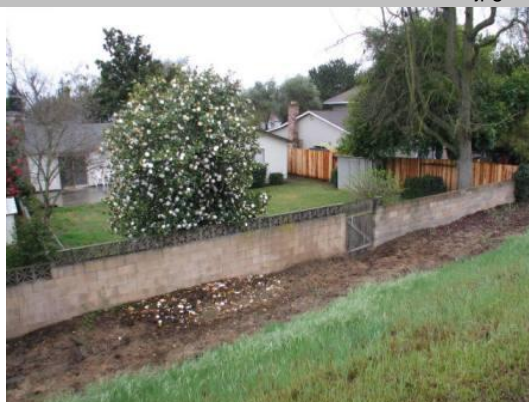
Photo 1 of 1 : mkhashch_s_20140428_00146.jpg

LM Start	8.23	Rating **	U	Issue No.	90
LM End	8.23	Issue Type +	En	Location *	LS
Category	Earthen Levee			GPS Latitude/Longitude	
				Start	End
Item	Encroachments			38.561544 °	38.561544 °
				-121.394494 °	-121.394494 °
DWR ID	DWR_NA0001_04_s _ 2012_90				
Action/Comments					
Fence					
Inspector Comments: Cement block fence within 10-ft of the levee toe.

03/16/2012 Cinder block wall completely obstructs access and visibility.

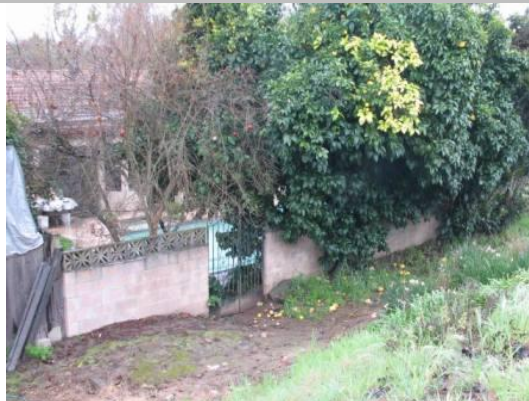
Photo 1 of 1 : mkhashch_s_20140428_00148.jpg

LM Start	8.25	Rating **	U	Issue No.	92
LM End	8.25	Issue Type +	En	Location *	LS
Category	Earthen Levee			GPS Latitude/Longitude	
				Start	End
Item	Encroachments			38.561658 °	38.561658 °
				-121.394157 °	-121.394157 °
DWR ID	DWR_NA0001_04_s _ 2012_92				
Action/Comments					
Fence Inspector Comments: Cement block fence and landscaping within 10-ft of levee toe obstructs access and visibility.

03/16/2012 Cinder block fence completely obstructs access and visibility.

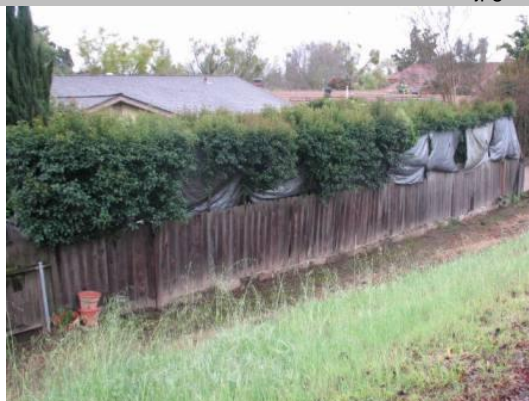
Photo 1 of 1 : mkhashch_s_20140428_00149.jpg

LM Start	8.27	Rating **	U	Issue No.	93
LM End	8.27	Issue Type +	En	Location *	LS
Category	Earthen Levee			GPS Latitude/Longitude	
				Start	End
Item	Encroachments			38.561750 °	38.561750 °
				-121.393917 °	-121.393917 °
DWR ID	DWR_NA0001_04_s _ 2012_93				
Action/Comments					
Fence Inspector Comments: Wooden fence, strung tarps, and landscaping within 10-ft of levee toe obstructs access and visibility.

03/16/2012 Wood privacy fence completely obstructs access and visibility.

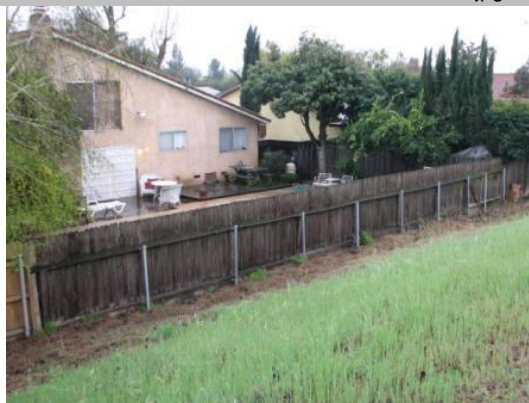
Photo 1 of 1 : mkhashch_s_20140428_00150.jpg

LM Start	8.28	Rating **	U	Issue No.	94
LM End	8.28	Issue Type +	En	Location *	LS
Category	Earthen Levee			GPS Latitude/Longitude	
				Start	End
Item	Encroachments			38.561799 °	38.561799 °
				-121.393758 °	-121.393758 °
DWR ID	DWR_NA0001_04_s _ 2012_94				
Action/Comments					
Fence Inspector Comments: Wood privacy fence and pool within 10-ft of levee toe obstructs access and visibility.

03/16/2012 Wood privacy fence completely obstructs access and visibility.

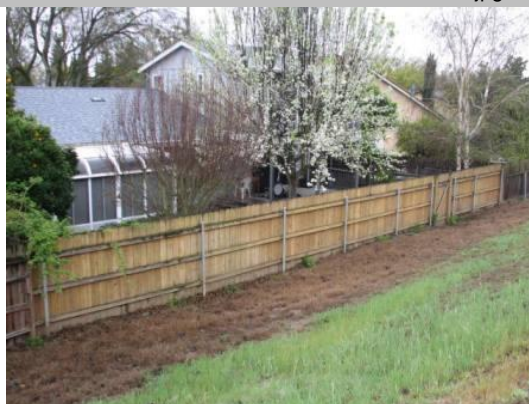
Photo 1 of 1 : mkhashch_s_20140428_00151.jpg

LM Start	8.29	Rating **	U	Issue No.	95
LM End	8.29	Issue Type +	En	Location *	LS
Category	Earthen Levee			GPS Latitude/Longitude	
				Start	End
Item	Encroachments			38.561900 °	38.561900 °
				-121.393547 °	-121.393547 °
DWR ID	DWR_NA0001_04_s _ 2012_95				
Action/Comments					
Fence Inspector Comments: Wood privacy fence within 10-ft of levee toe obstructs access and visibility.

03/16/2012 Wood privacy fence completely obstructs access and visibility.

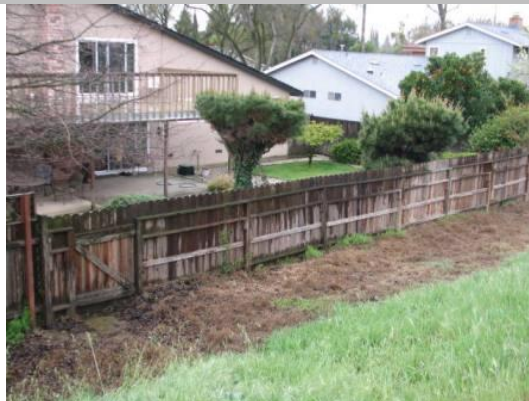
Photo 1 of 1 : mkhashch_s_20140428_00153.jpg

LM Start	8.31	Rating **	U	Issue No.	97
LM End	8.31	Issue Type +	En	Location *	LS
Category	Earthen Levee			GPS Latitude/Longitude	
				Start	End
Item	Encroachments			38.561986 °	38.561986 °
				-121.393343 °	-121.393343 °
DWR ID	DWR_NA0001_04_s _ 2012_97				
Action/Comments					
Fence Inspector Comments: Wood privacy fence within 10-ft of levee toe obstructs access and visibility.

03/16/2012 Wood privacy fence completely obstructs access and visibility.

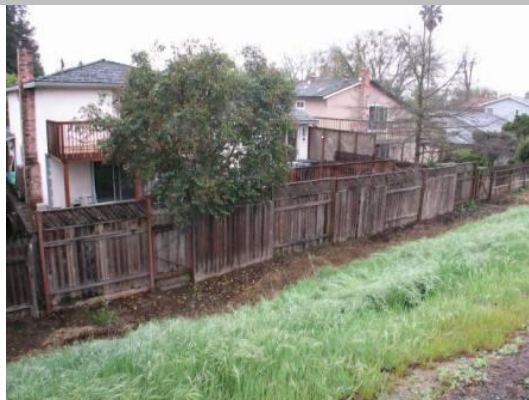
Photo 1 of 1 : mkhashch_s_20140428_00154.jpg

LM Start	8.32	Rating **	U	Issue No.	98
LM End	8.32	Issue Type +	En	Location *	LS
Category	Earthen Levee			GPS Latitude/Longitude	
				Start	End
Item	Encroachments			38.562054 °	38.562054 °
				-121.393190 °	-121.393190 °
DWR ID	DWR_NA0001_04_s _ 2012_98				
Action/Comments					
Fence					
Inspector Comments: Wood privacy fence within 10-ft of levee toe obstructs access and visibility.

03/16/2012 Wood privacy fence completely obstructs access and visibility.

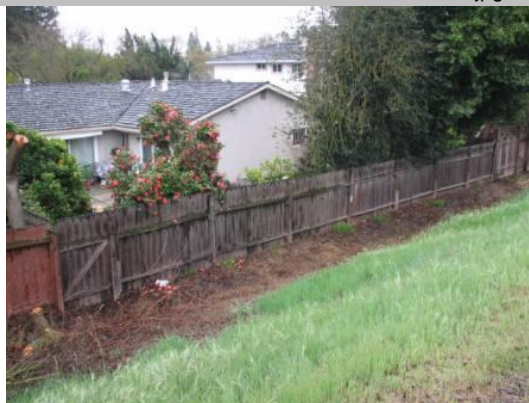
Photo 1 of 1 : mkhashch_s_20140428_00155.jpg

LM Start	8.33	Rating **	U	Issue No.	99
LM End	8.33	Issue Type +	En	Location *	LS
Category	Earthen Levee			GPS Latitude/Longitude	
				Start	End
Item	Encroachments			38.562120 °	38.562120 °
				-121.392983 °	-121.392983 °
DWR ID	DWR_NA0001_04_s _ 2012_99				
Action/Comments					
Fence Inspector Comments: Wood privacy fence within 10-ft of levee toe obstructs access and visibility.

03/16/2012 Wood privacy fence completely obstructs access and visibility.

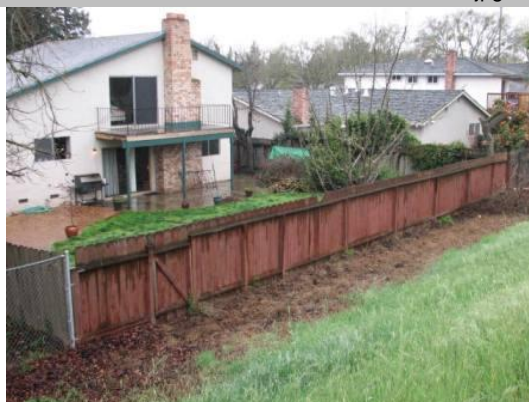
Photo 1 of 1 : mkhashch_s_20140428_00156.jpg

LM Start	8.34	Rating **	U	Issue No.	100
LM End	8.34	Issue Type +	En	Location *	LS
Category	Earthen Levee			GPS Latitude/Longitude	
				Start	End
Item	Encroachments			38.562182 °	38.562182 °
				-121.392778 °	-121.392778 °
DWR ID	DWR_NA0001_04_s _ 2012_100				
Action/Comments					
Fence Inspector Comments: Wood privacy fence within 10-ft of levee toe obstructs access and visibility.

03/16/2012 Wood privacy fence completely obstructs access and visibility.

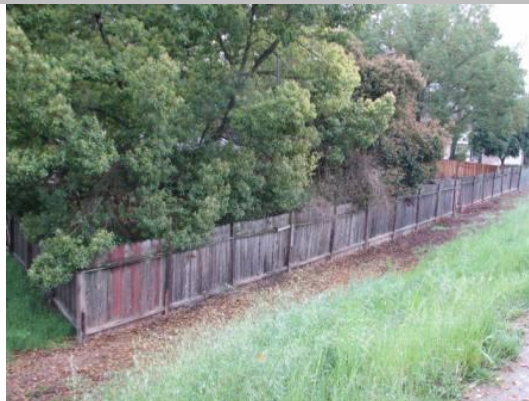
Photo 1 of 1 : mkhashch_s_20140428_00157.jpg

LM Start	8.39	Rating **	U	Issue No.	101
LM End	8.39	Issue Type +	En	Location *	LS
Category	Earthen Levee			GPS Latitude/Longitude	
				Start	End
Item	Encroachments			38.562508 °	38.562508 °
				-121.392037 °	-121.392037 °
DWR ID	DWR_NA0001_04_s _ 2012_101				
Action/Comments					
Fence Inspector Comments: Wood privacy fence within 10-ft of levee toe obstructs access and visibility.

03/16/2012 Wood privacy fence completely obstructs access and visibility.

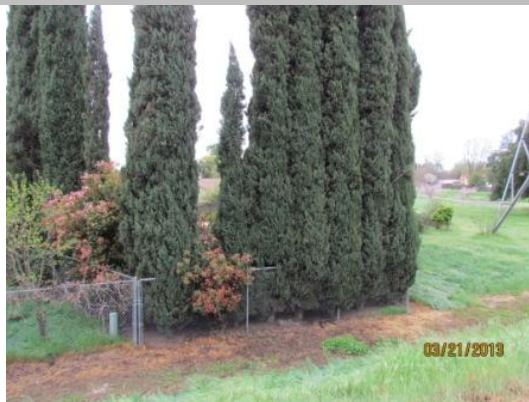
Photo 1 of 1 : mkhashch_s_20140428_00158.jpg

LM Start	8.45	Rating **	M	Issue No.	102
LM End	8.45	Issue Type +	En	Location *	LS
Category	Earthen Levee			GPS Latitude/Longitude	
				Start	End
Item	Vegetation			38.562889 °	38.562889 °
				-121.391042 °	-121.391042 °
DWR ID	DWR_NA0001_04_s _ 2012_102				
Action/Comments					
Landscaping					
Inspector Comments: Helix sky pencil along chain link fence is within 10-ft of the levee toe.

View of the landscaping at the levee toe.

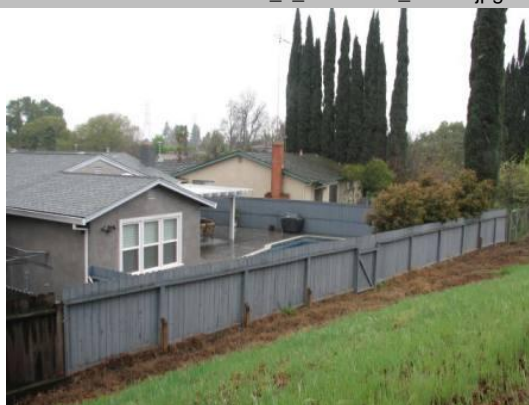
Photo 1 of 1 : mkhashch_s_20140428_00159.jpg

LM Start	8.47	Rating **	U	Issue No.	103
LM End	8.47	Issue Type +	En	Location *	LS
Category	Earthen Levee			GPS Latitude/Longitude	
				Start	End
Item	Encroachments			38.563042 °	38.563042 °
				-121.390692 °	-121.390692 °
DWR ID	DWR_NA0001_04_s _ 2012_103				
Action/Comments					
Fence					
Inspector Comments: Wood privacy fence within 10-ft of levee toe obstructs access and visibility.

03/16/2012 Wood privacy fence completely obstructs access and visibility.

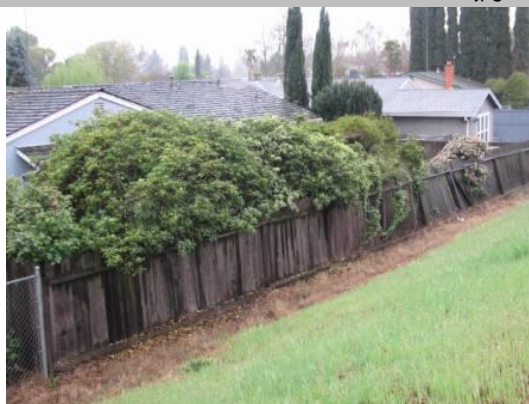
Photo 1 of 1 : mkhashch_s_20140428_00160.jpg

LM Start	8.48	Rating **	U	Issue No.	104
LM End	8.48	Issue Type +	En	Location *	LS
Category	Earthen Levee			GPS Latitude/Longitude	
				Start	End
Item	Encroachments			38.563108 °	38.563108 °
				-121.390452 °	-121.390452 °
DWR ID	DWR_NA0001_04_s _ 2012_104				
Action/Comments					
Fence					
Inspector Comments: Wood privacy fence within 10-ft of levee toe obstructs access and visibility.

03/16/2012 Wood privacy fence completely obstructs access and visibility.

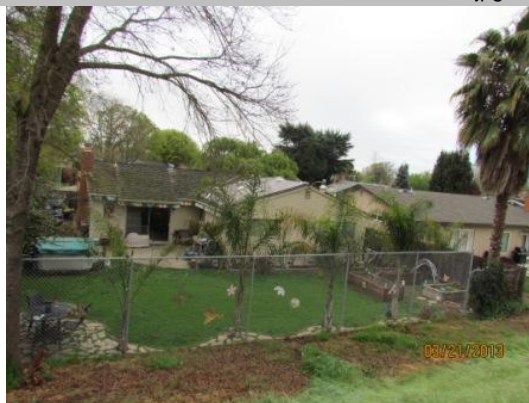
Photo 1 of 1 : mkhashch_s_20140428_00161.jpg

LM Start	8.51	Rating **	M	Issue No.	105
LM End	8.51	Issue Type +	En	Location *	LS
Category	Earthen Levee			GPS Latitude/Longitude	
				Start	End
Item	Vegetation			38.563238 °	38.563238 °
				-121.390073 °	-121.390073 °
DWR ID	DWR_NA0001_04_s _ 2012_105				
Action/Comments					
Landscaping					
Inspector Comments: Palms planted within 10-ft of the levee toe.

View of the palm trees at the levee toe.

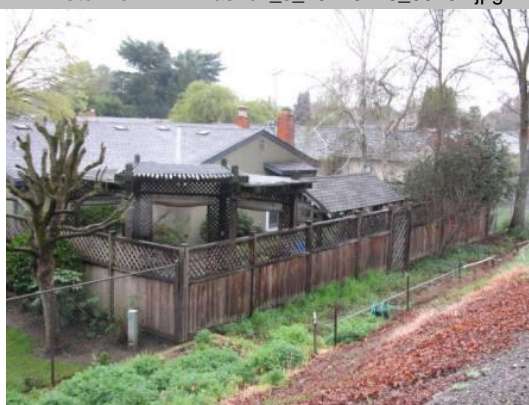
Photo 1 of 1 : mkhashch_s_20140428_00162.jpg

LM Start	8.52	Rating **	U	Issue No.	106
LM End	8.52	Issue Type +	En	Location *	LS
Category	Earthen Levee			GPS Latitude/Longitude	
				Start	End
Item	Encroachments			38.563308 °	38.563308 °
				-121.389885 °	-121.389885 °
DWR ID	DWR_NA0001_04_s _ 2012_106				
Action/Comments					
Fence					
Inspector Comments: Wood privacy fence within 10-ft of levee toe obstructs access and visibility. Block wall built into the levee.

03/16/2012 Wood privacy fence completely obstructs access and visibility.

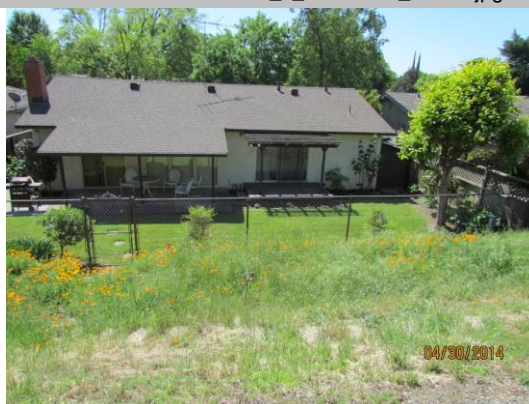
Photo 1 of 1 : mkhashch_s_20140509_00973.jpg

LM Start	8.53	Rating **	M	Issue No.	246
LM End	8.53	Issue Type +	En	Location *	LS
Category	Earthen Levee			GPS Latitude/Longitude	
				Start	End
Item	Encroachments			38.563434 °	38.563434 °
				-121.389675 °	-121.389675 °
DWR ID	DWR_NA0001_04_s _ 2014_246				
Action/Comments					
Retaining Wall					
Inspector Comments: Retaining wall and irrigation at landside levee toe.

View of the irrigation and retaining wall at the landside levee toe.

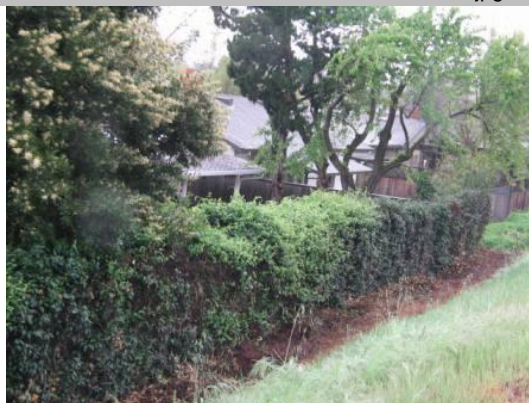
Photo 1 of 1 : mkhashch_s_20140428_00163.jpg

LM Start	8.54	Rating **	U	Issue No.	107
LM End	8.54	Issue Type +	En	Location *	LS
Category	Earthen Levee			GPS Latitude/Longitude	
				Start	End
Item	Vegetation			38.563511 °	38.563511 °
				-121.389509 °	-121.389509 °
DWR ID	DWR_NA0001_04_s _ 2012_107				
Action/Comments					
Landscaping

03/16/2012 Landscaping obstructs visibility and access.

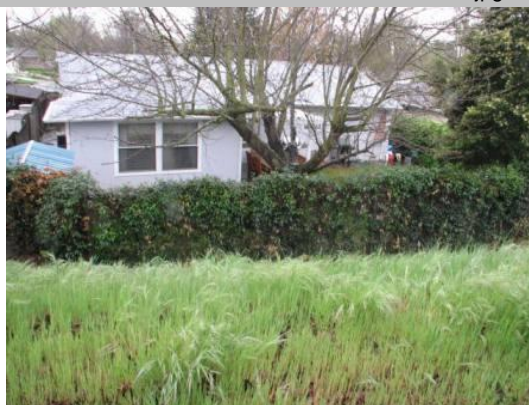
Photo 1 of 1 : mkhashch_s_20140428_00164.jpg

LM Start	8.55	Rating **	U	Issue No.	108
LM End	8.55	Issue Type +	En	Location *	LS
Category	Earthen Levee			GPS Latitude/Longitude	
				Start	End
Item	Vegetation			38.563587 °	38.563587 °
				-121.389313 °	-121.389313 °
DWR ID	DWR_NA0001_04_s _ 2012_108				
Action/Comments					
Landscaping

03/16/2012 Landscaping obstructs visibility and access.

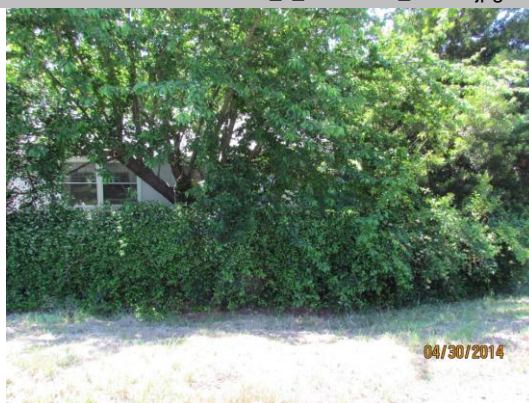
Photo 1 of 1 : mkhashch_s_20140509_00972.jpg

LM Start	8.56	Rating **	M	Issue No.	236
LM End	8.56	Issue Type +	En	Location *	LS
Category	Earthen Levee			GPS Latitude/Longitude	
				Start	End
Item	Vegetation			38.566948 °	38.566948 °
				-121.371562 °	-121.371562 °
DWR ID	DWR_NA0001_04_s _ 2012_236				
Action/Comments					
Landscaping					
Inspector Comments: Landscaping within 10-ft of levee toe.

View of the landscaping at the landside levee to obstructing visibility and access.

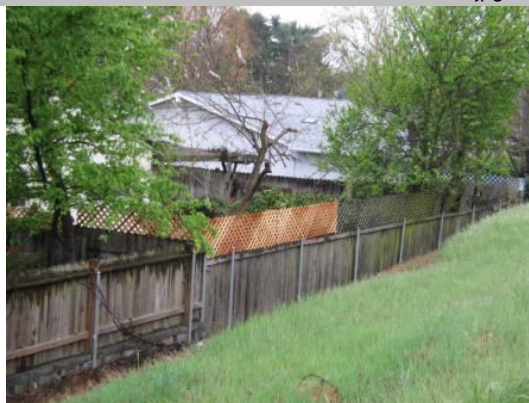
Photo 1 of 1 : mkhashch_s_20140428_00165.jpg

LM Start	8.57	Rating **	U	Issue No.	109
LM End	8.57	Issue Type +	En	Location *	LS
Category	Earthen Levee			GPS Latitude/Longitude	
				Start	End
Item	Encroachments			38.563580 °	38.563580 °
				-121.389140 °	-121.389140 °
DWR ID	DWR_NA0001_04_s _ 2012_109				
Action/Comments					
Fence Inspector Comments: Wood privacy fence within 10-ft of levee toe obstructs access and visibility.

03/16/2012 Wood privacy fence completely obstructs access and visibility.

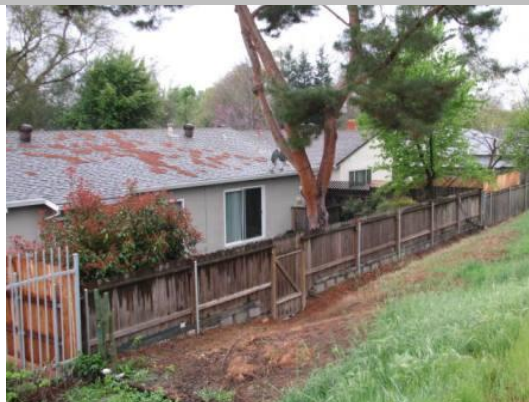
Photo 1 of 1 : mkhashch_s_20140428_00166.jpg

LM Start	8.58	Rating **	U	Issue No.	110
LM End	8.58	Issue Type +	En	Location *	LS
Category	Earthen Levee			GPS Latitude/Longitude	
				Start	End
Item	Encroachments			38.563732 °	38.563732 °
				-121.388930 °	-121.388930 °
DWR ID	DWR_NA0001_04_s _ 2012_110				
Action/Comments					
Fence Inspector Comments: Wood privacy fence within 10-ft of levee toe obstructs access and visibility.

03/16/2012 Wood privacy fence completely obstructs access and visibility.

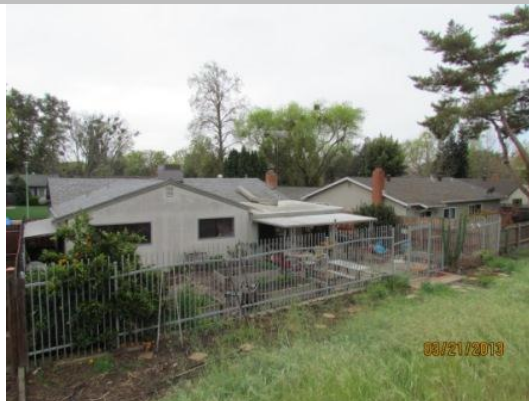
Photo 1 of 1 : mkhashch_s_20140428_00258.jpg

LM Start	8.59	Rating **	M	Issue No.	226
LM End	8.59	Issue Type +	En	Location *	LS
Category	Earthen Levee			GPS Latitude/Longitude	
				Start	End
Item	Vegetation			38.563793 °	38.563793 °
				-121.388758 °	-121.388758 °
DWR ID	DWR_NA0001_04_s_2012_226				
Action/Comments					
Landscaping Inspector Comments: Garden, trees and cactus planted against the levee toe.

View of landscaping at the levee toe.

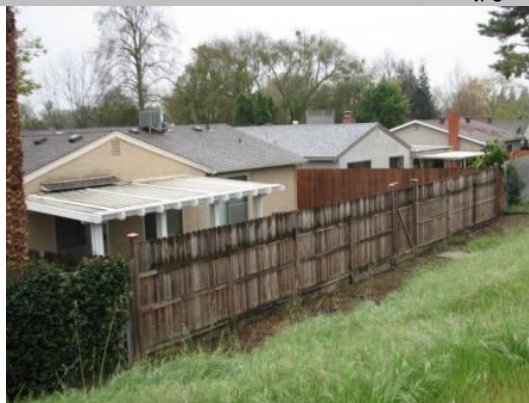
Photo 1 of 1 : mkhashch_s_20140428_00167.jpg

LM Start	8.60	Rating **	U	Issue No.	111
LM End	8.60	Issue Type +	En	Location *	LS
Category	Earthen Levee			GPS Latitude/Longitude	
				Start	End
Item	Encroachments			38.563820 °	38.563820 °
				-121.388518 °	-121.388518 °
DWR ID	DWR_NA0001_04_s_2012_111				
Action/Comments					
Fence Inspector Comments: Wood privacy fence within 10-ft of levee toe obstructs access and visibility.

03/16/2012 Wood privacy fence completely obstructs access and visibility.

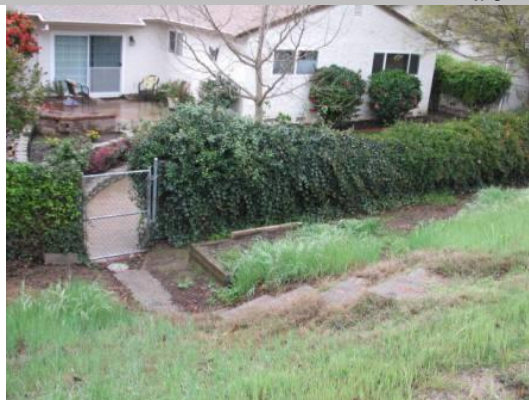
Photo 1 of 1 : mkhashch_s_20140428_00169.jpg

LM Start	8.61	Rating **	U	Issue No.	113
LM End	8.61	Issue Type +	En	Location *	LS
Category	Earthen Levee			GPS Latitude/Longitude	
				Start	End
Item	Vegetation			38.563877 °	38.563877 °
				-121.388343 °	-121.388343 °
DWR ID	DWR_NA0001_04_s_2012_113				
Action/Comments					
Landscaping

03/16/2012 Landscaping on chainlink fence blocks visibility and access.

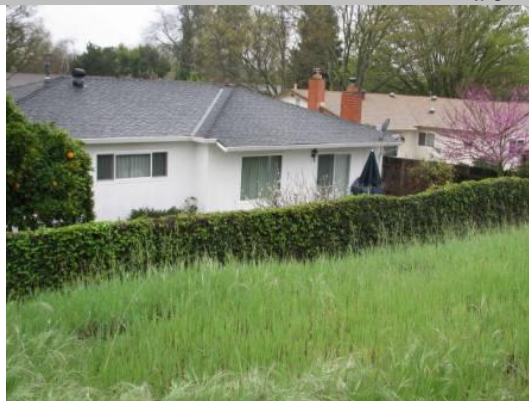
Photo 1 of 1 : mkhashch_s_20140428_00170.jpg

LM Start	8.63	Rating **	U	Issue No.	114
LM End	8.63	Issue Type +	En	Location *	LS
Category	Earthen Levee			GPS Latitude/Longitude	
				Start	End
Item	Vegetation			38.563945 °	38.563945 °
				-121.388137 °	-121.388137 °
DWR ID	DWR_NA0001_04_s _ 2012_114				
Action/Comments					
Landscaping					
Inspector Comments: Ivy and orange tree obstruct visibility.

03/16/2012 Ivy on chainlink fence completely obstructs visibility and access.

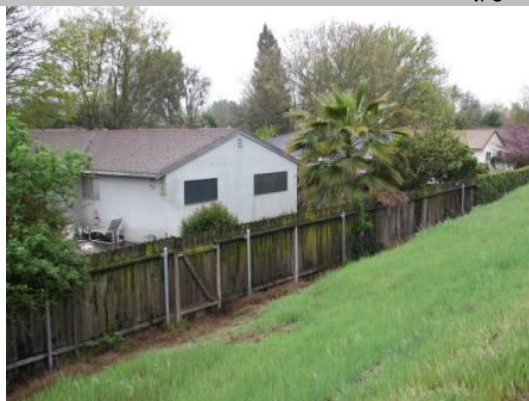
Photo 1 of 1 : mkhashch_s_20140428_00171.jpg

LM Start	8.65	Rating **	U	Issue No.	115
LM End	8.65	Issue Type +	En	Location *	LS
Category	Earthen Levee			GPS Latitude/Longitude	
				Start	End
Item	Encroachments			38.564047 °	38.564047 °
				-121.387743 °	-121.387743 °
DWR ID	DWR_NA0001_04_s _ 2012_115				
Action/Comments					
Fence					
Inspector Comments: Wood privacy fence and 2-story play house within 10-ft of levee toe obstructs access and visibility.

03/16/2012 Wood privacy fence completely obstructs access and visibility.

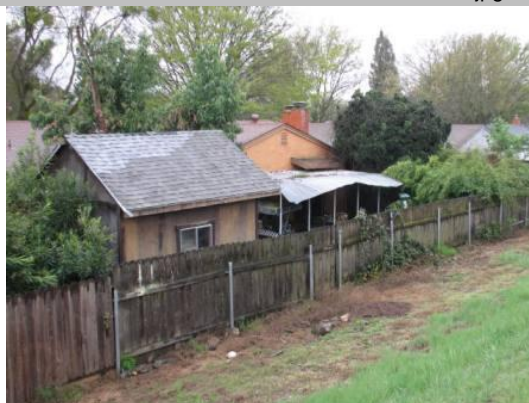
Photo 1 of 1 : mkhashch_s_20140428_00173.jpg

LM Start	8.66	Rating **	U	Issue No.	117
LM End	8.66	Issue Type +	En	Location *	LS
Category	Earthen Levee			GPS Latitude/Longitude	
				Start	End
Item	Encroachments			38.564033 °	38.564033 °
				-121.387572 °	-121.387572 °
DWR ID	DWR_NA0001_04_s _ 2012_117				
Action/Comments					
Fence					
Inspector Comments: Wood privacy fence and wood out building within 10-ft of levee toe obstructs access and visibility.

03/16/2012 Wood privacy fence completely obstructs access and visibility.
